July 9, 2015  
60309395

Subject: Journey's End Community Development District – Annual Report

**Journey's End Community Development District Inspection Photographs**

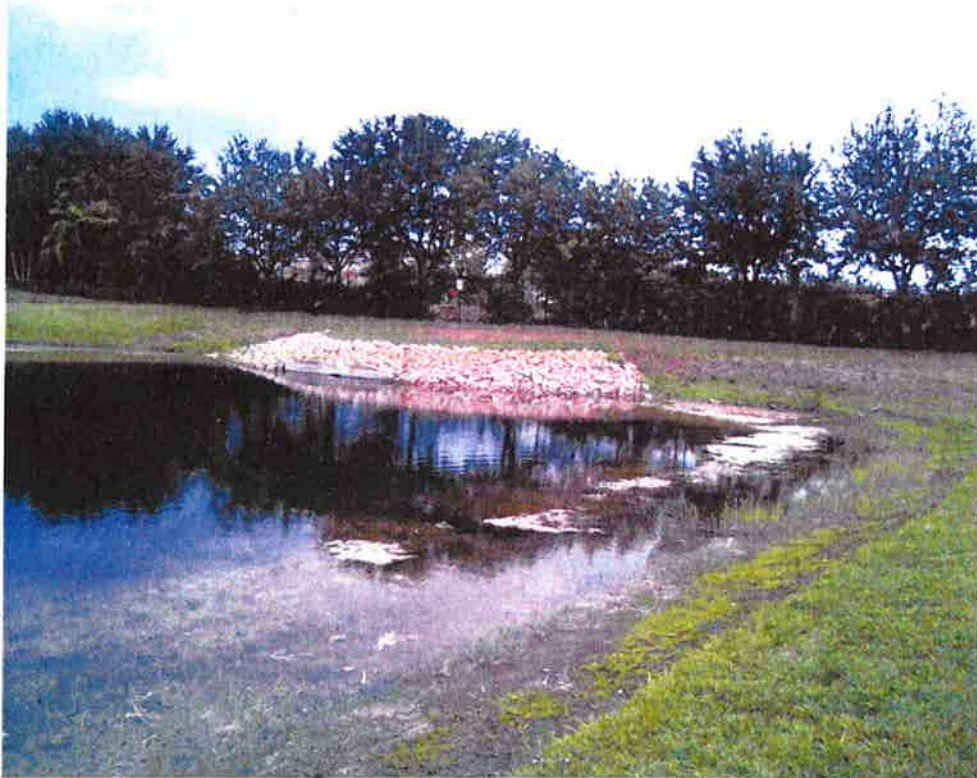
**Figure 27 – East End of Lake 7 near JECDD Outfall Structure on 05/29/2015**

1. The erosion protection around the upstream end of the outfall headwall was completed this past year and is in good condition (see Figure 27).
2. The chain link fence located at the outfall control structure between JECDD and Lake Worth Drainage District's (LWDD) L-16 Canal right-of-way has been replaced with a wrought iron fence.
3. The catch basins located in the roadways were clean of trash.
