July 9, 2015  
60309395

Subject: Journey's End Community Development District – Annual Report

**Journey's End Community Development District Inspection Photographs**

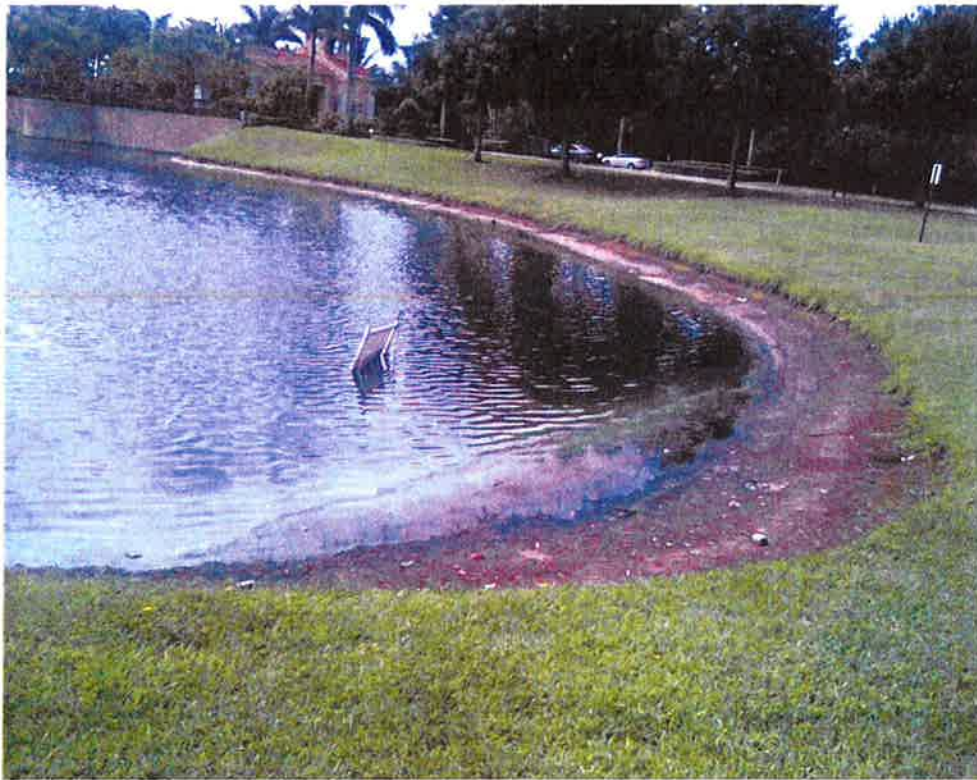
**Figure 1 – West End of Lake 1 Looking East on 05/29/2015**

1. All the lakes are currently low as it is the end of the dry season, and it is apparent that several of the lakes' banks have experienced additional erosion since we reported last year. At some locations in excess of a 24" vertical lip was observed due to the low water levels.
2. Implementation of a quarterly maintenance schedule for the storm water control structures, including catch basins and vegetation control around culvert connections within all lakes is recommended. The vegetation was still overgrown at the end of the pipe on one of the Lake 3 interconnects, as reported last year; trash and litter were noted in the catch basins near the clubhouse.
